DELAWARE RIVER BASIN
BLAIR CREEK, WARREN COUNTY
NEW JERSEY

BLAIR LAKE DAM NJ 00774

PHASE 1 INSPECTION REPORT
NATIONAL DAM SAFETY PROGRAM

AUGUST 1981

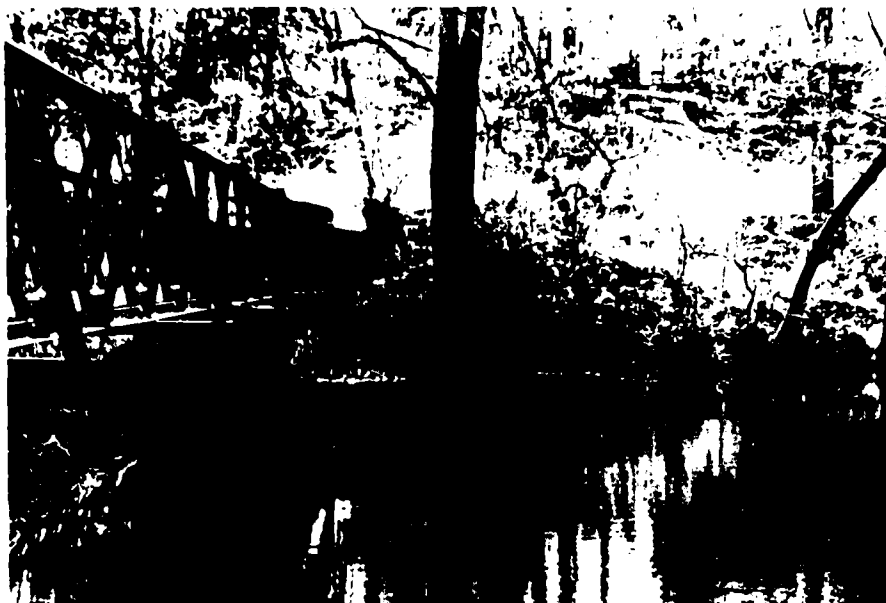
View looking at right upstream dam and spillway abutment; upsloping berm is left bank of old mill race. Note erosion and growth of large trees with roots exposed adjacent to dam.

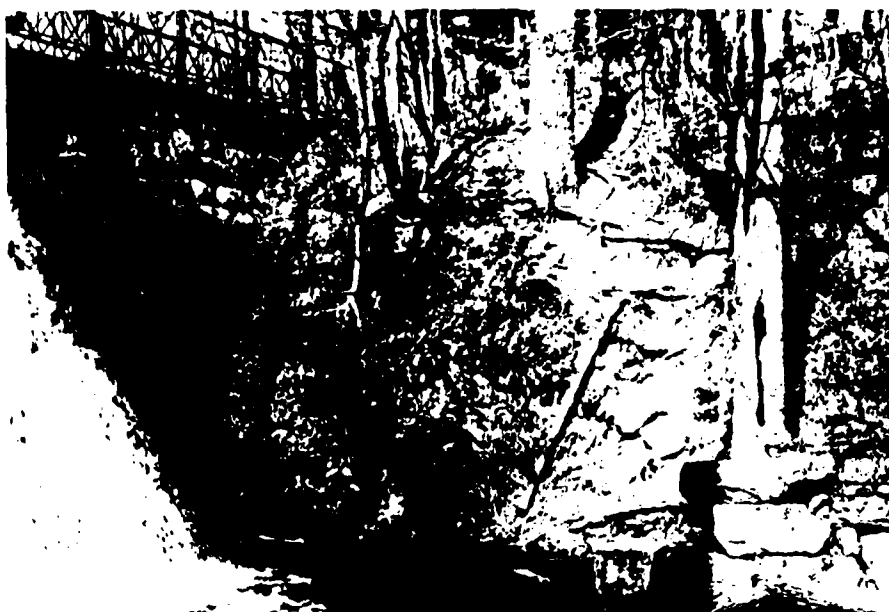
c. Visual Observation. The spillway appears to be in good condition. At the left spillway abutment downstream, the bedrock is seriously undermined in part, caused by tree roots that have spread along the joint planes. The dam now has no low-level outlet; the old mill race has been blocked off and the gate in the mill building is closed and presumed to be inoperable. Because the low chord of the bridge is just below top of dam, the condition of the bridge is important in the event of overtopping. The poor structural condition of the trusses, caused by corrosion, makes the bridge a liability to the integrity of the dam if it should collapse.

View of downstream left spillway abutment contact; note trees up to 14-inch diameter on slope, erosion, debris, and portions of lined downstream channel wall missing.

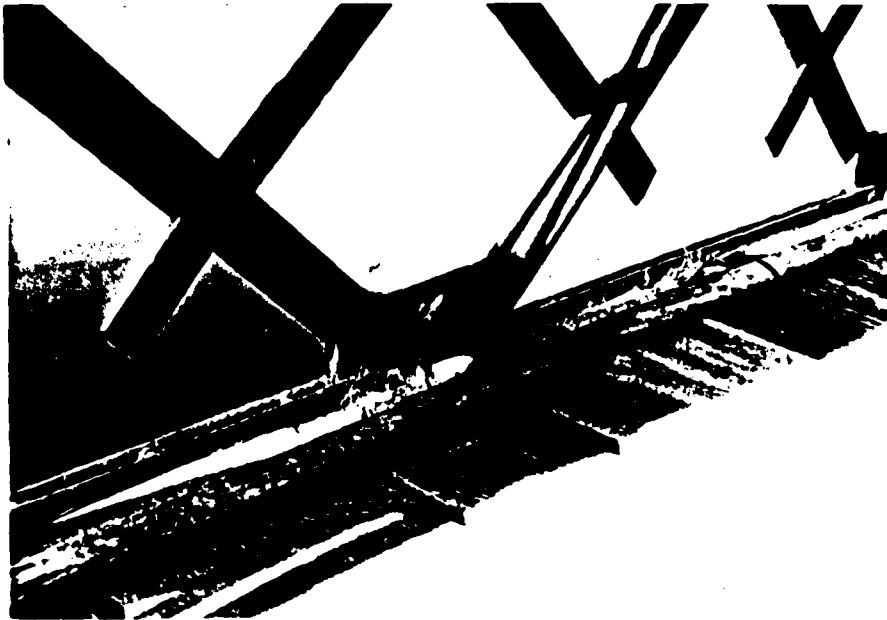
b. Appurtenant Structure. Service bridge: major corrosion of the bottom chord joint gusset plates has substantially reduced the effectiveness of the bridge truss. The wood deck planking is weathered with several planks observed to be deteriorated.

Gusset plates rusted through on bridge over spillway.

Investigate impact of corrosion and make repairs.

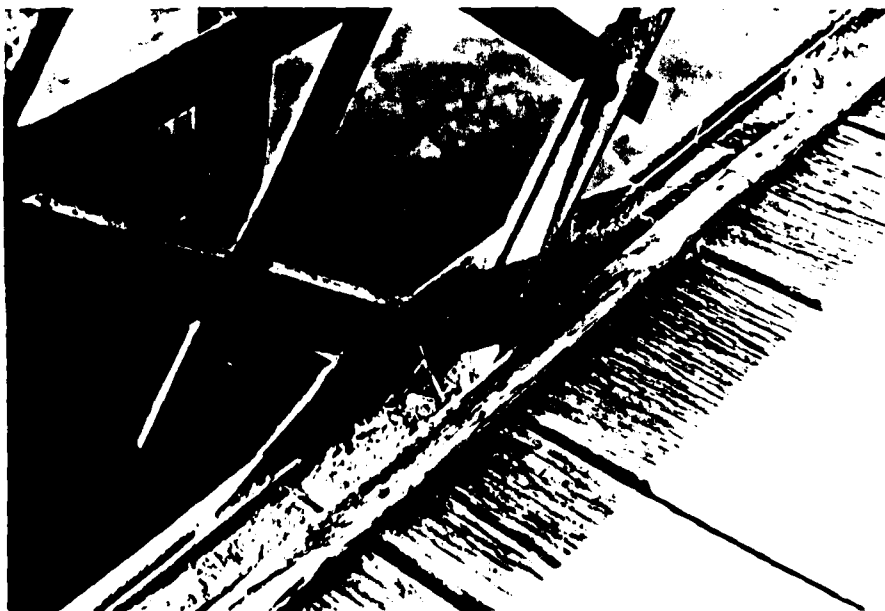
Rust eaten gussets on upstream truss; note that rust is eating into truss angle bars.

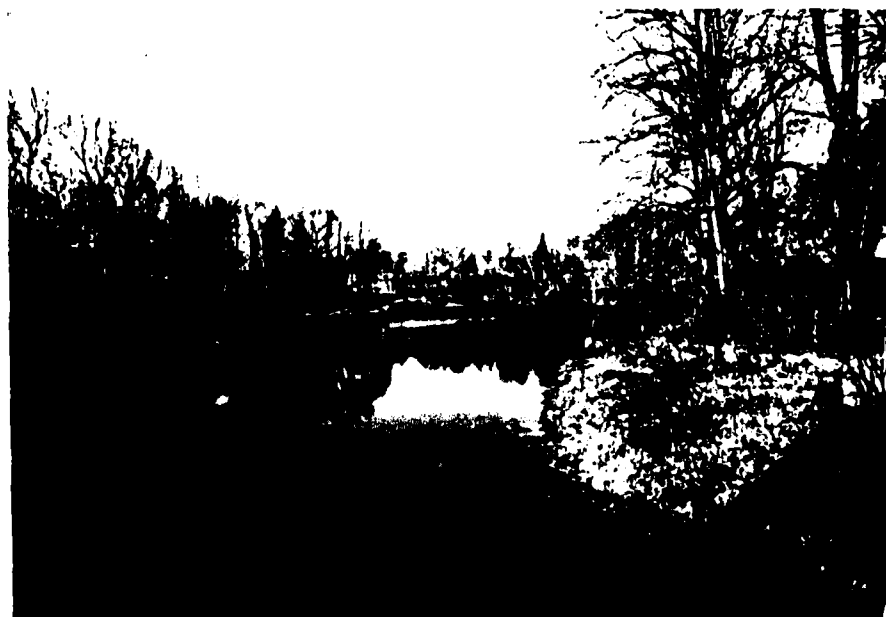
View looking upstream across reservoir at inlet from Blair
Creek; note that flow must turn nearly a right angle to
pass over spillway.

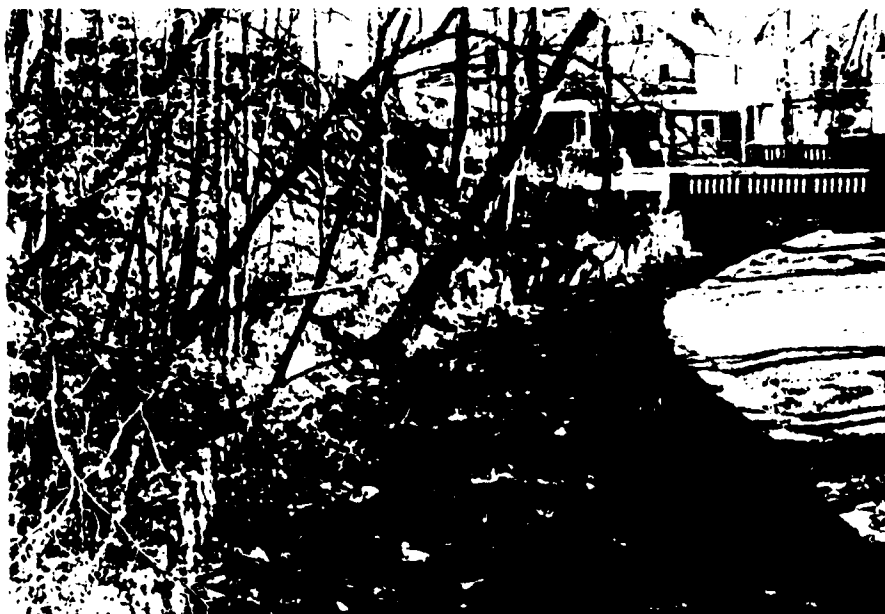
View looking at downstream channel from right bank at dam;
note Main Street Bridge.

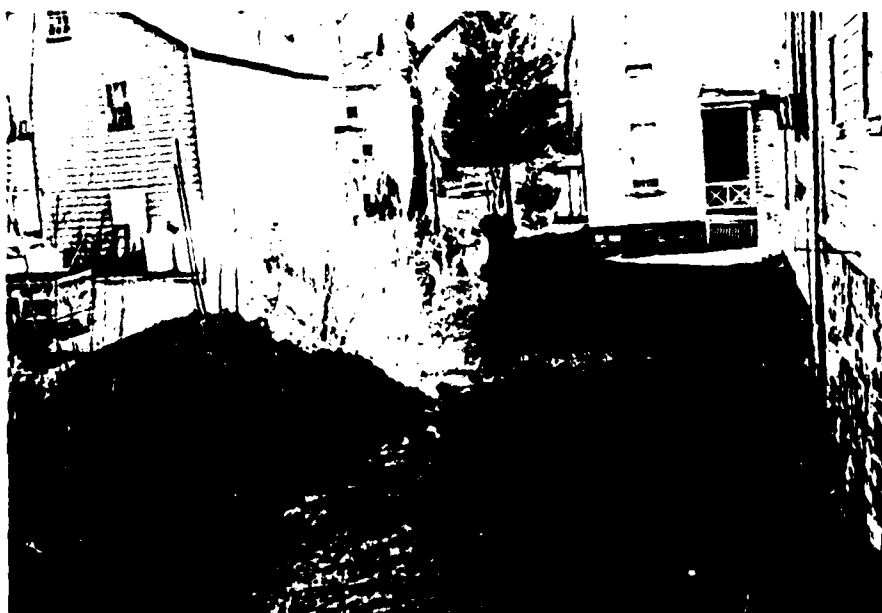
View looking downstream from downstream side of Main Street
Bridge.
